Summary

New Ageing Work

Appendix 1: 18000-hour Final test Update

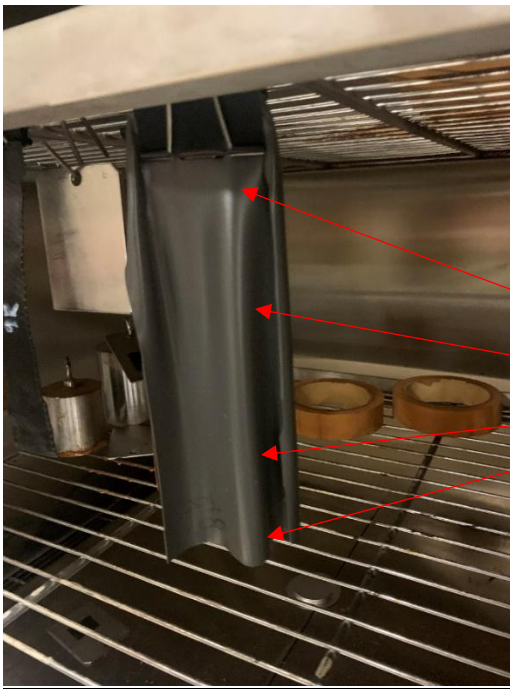
Sample suspended under its own weight

Measurements completed over length of sample 1-6

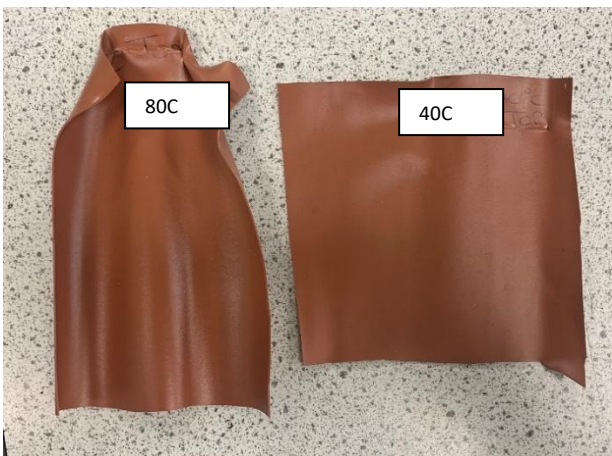
Appearance Post Temp exposure

Note the contraction / folding over shown by the sample exposed to higher temps

100C is similar to 80C above in appearance

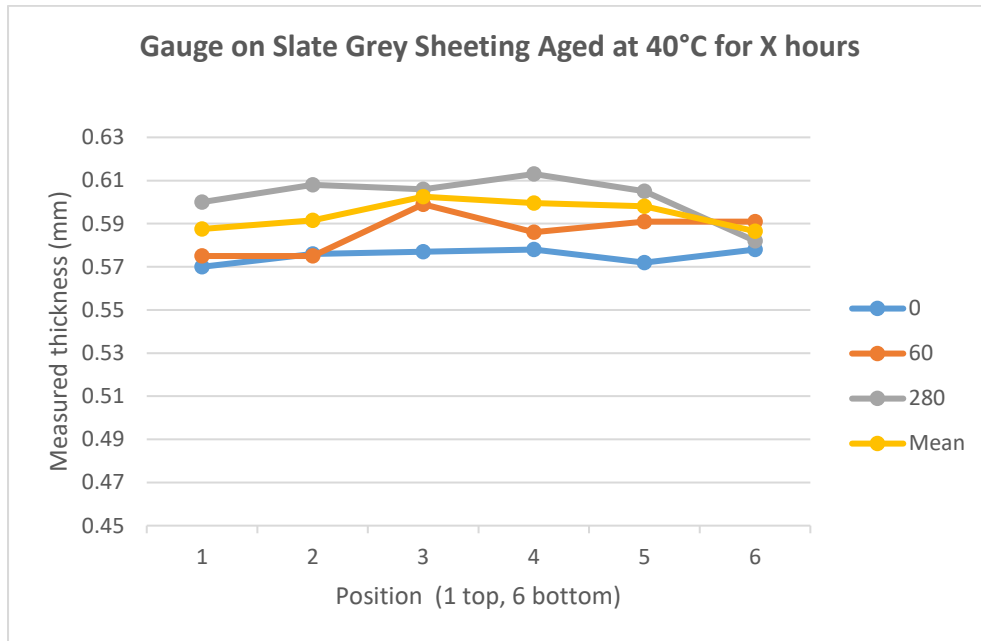
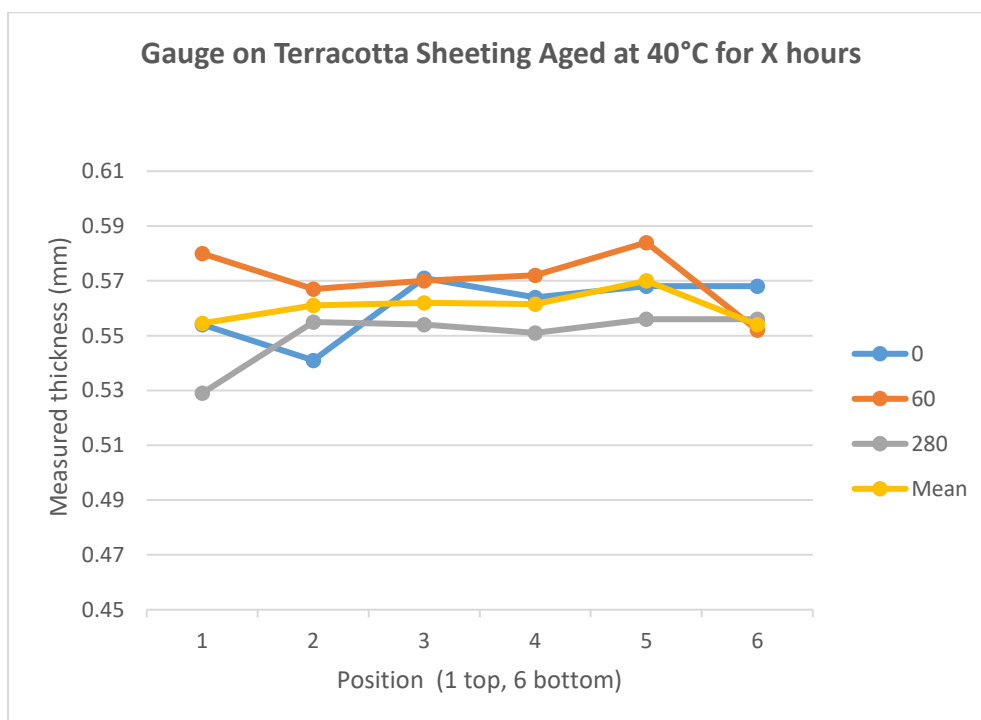
40°C

- No shifts in thickness – no flow noted. As per 50C measured and shown earlier in the development process
- No cracking or deformation of the sheeting, no colour change noted

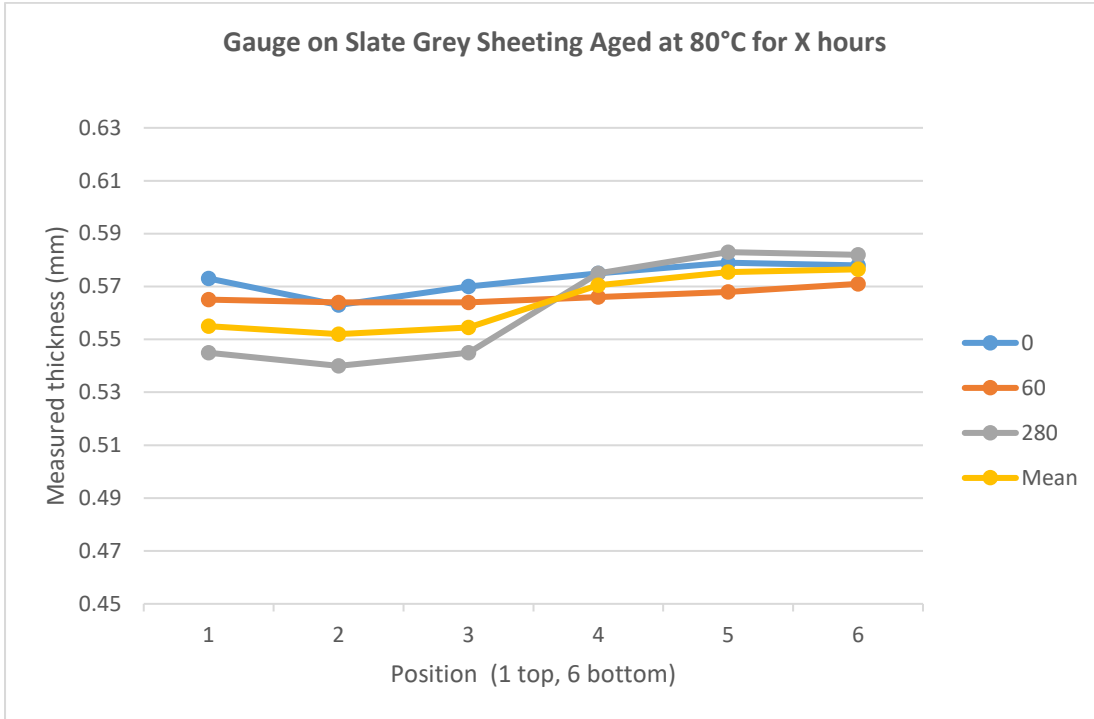
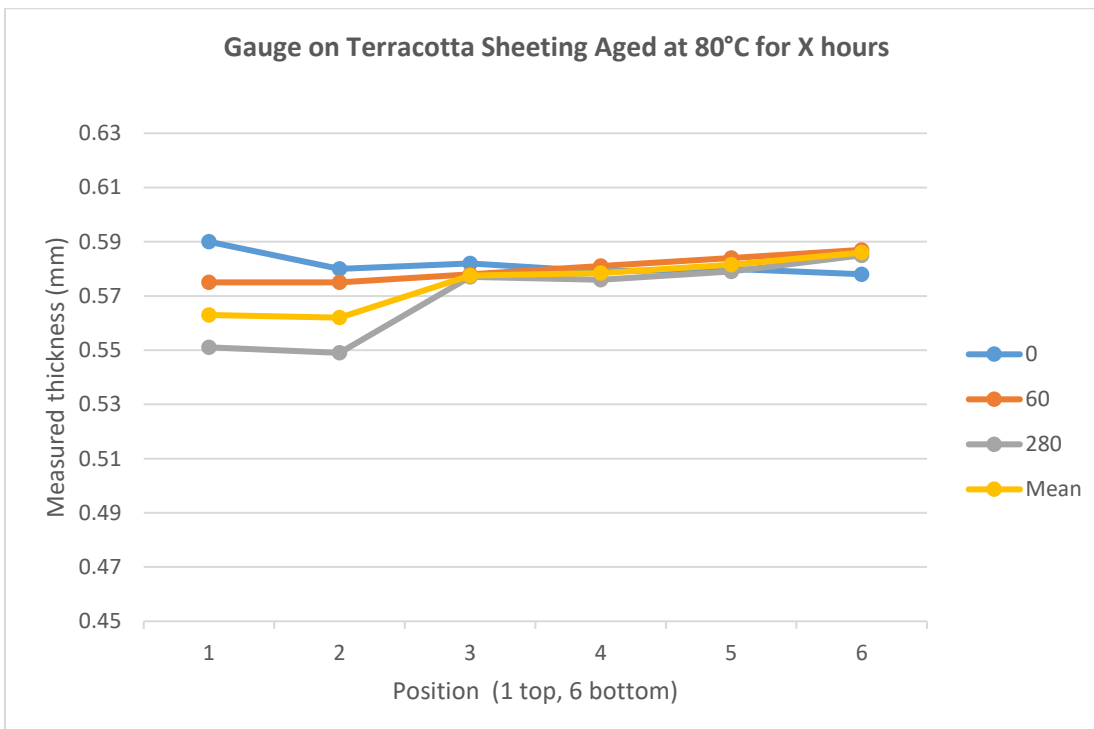
80°C

- Some evidence of flow, if all colour data considered together – although any overall trend is very small, it is probably existent (fig 5 below) – increase of approx. 0.02mm or 3.5% of gauge downwards over length of material assessed

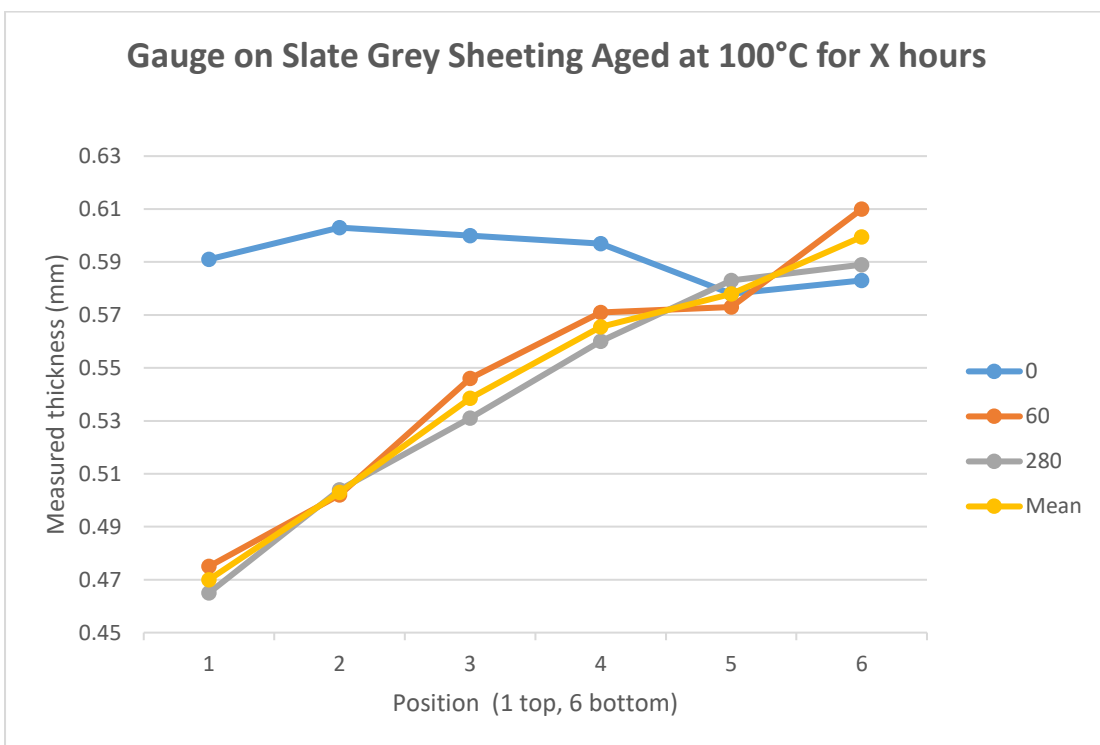
100°C

- Flow occurs in first 60 hours...however rate appears to tail off after that and flow ceases.

Note how the profile is the same for 60 hours as 280 hours.

Also note though a 'flow' of around 0.15mm over the time observed...ca 25% of the original thickness

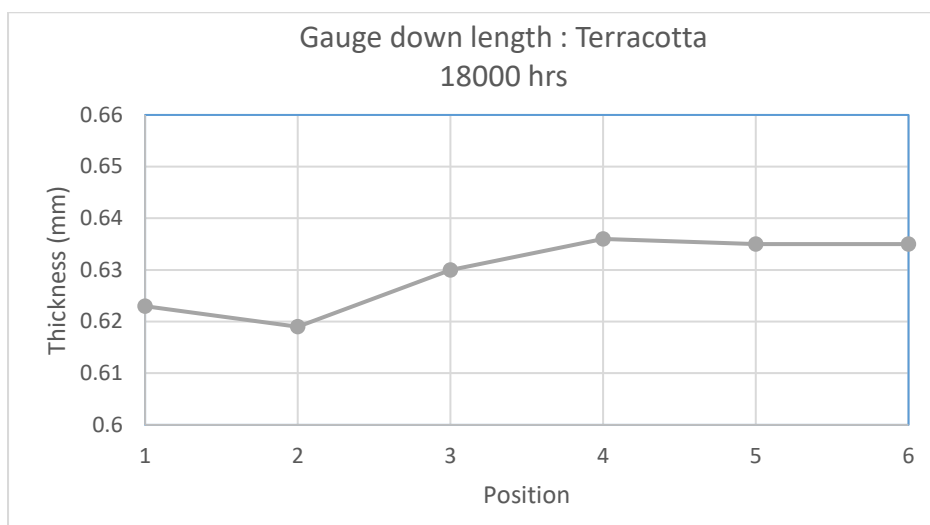
18000Hrs

No evidence therefore for flow over a 24-year equivalent period

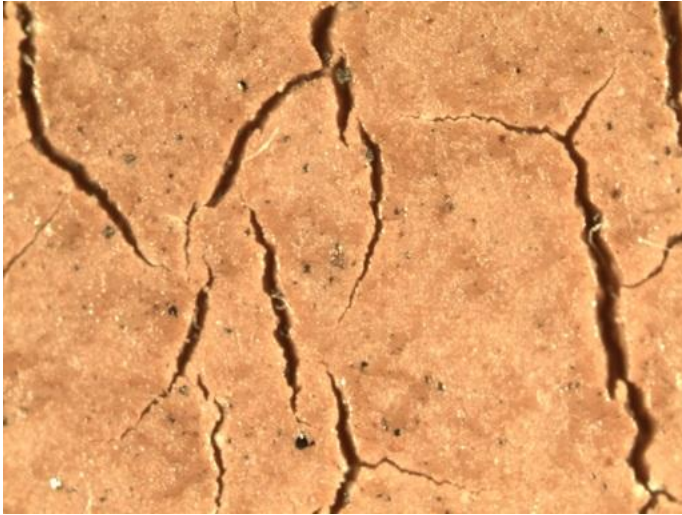
18000 Hours Exposed side

There are some surface cracks and slight discoloration as would be expected after 24 years in UV
 HOWEVER none of the cracks are beyond superficial and the unexposed side is completely unaffected.

Some cracks and discolouration (as seen on 10x magnification photo above) but the colour change is largely felt to be continued application of water leading to dirt build up.

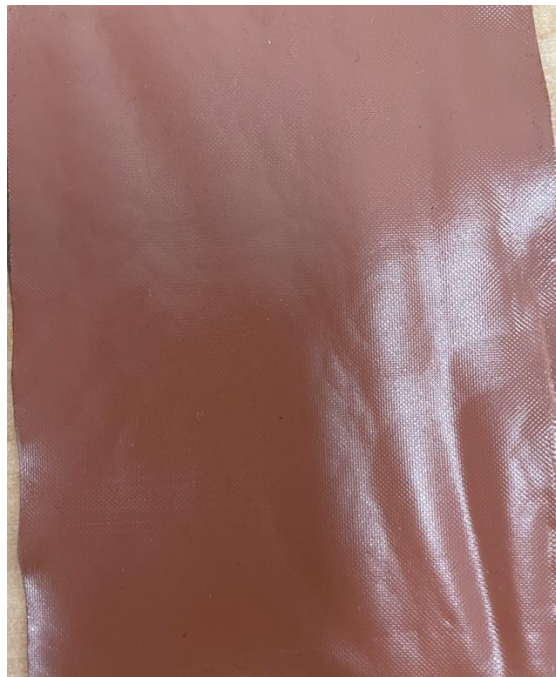
Reverse (Not exposed) same sample

Reverse side remains PRISTINE. Zero Water penetration possible. Zero discolouration. The LDPE film on the back was indeed as per original and easily peeled off the reverse of the sample.

No ageing impacts therefore noted through the whole sample thickness – surface effect only
